Measurement of Plastic Stress and Strain for Analytical Method Verification

**(MSFC Center Director's Discretionary Fund Final Report,
Project No. 93-08)**

J.M. Price, B.E. Steeve, and G.R. Swanson

TECHNICAL MEMORANDUM

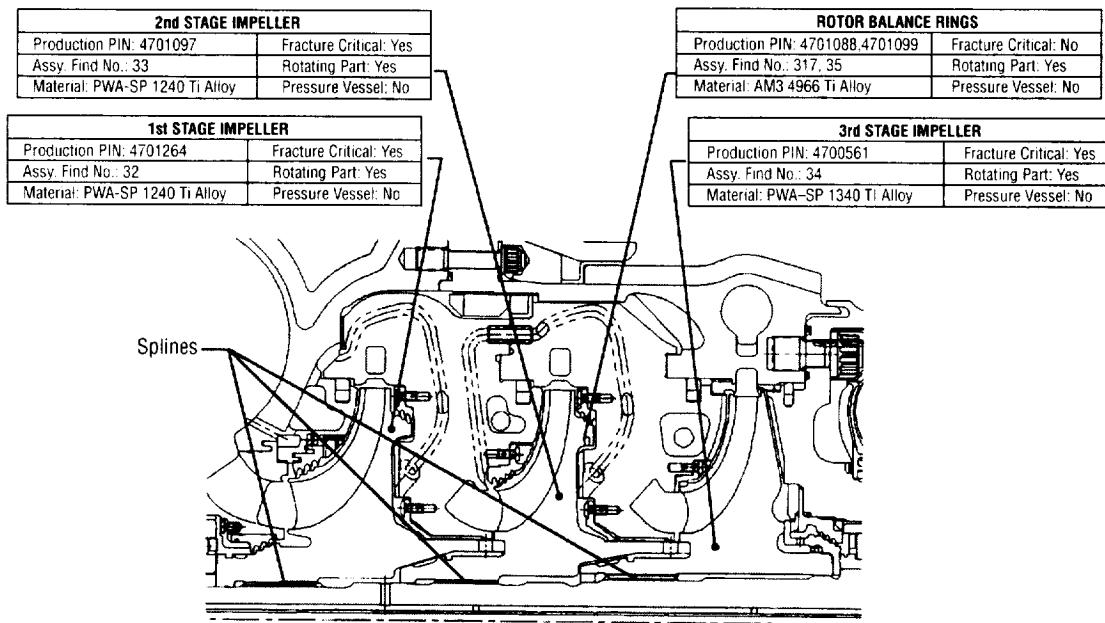
Figure 1. Cross section of the Pratt and Whitney AT/HPFTP pump end showing the impeller locations.

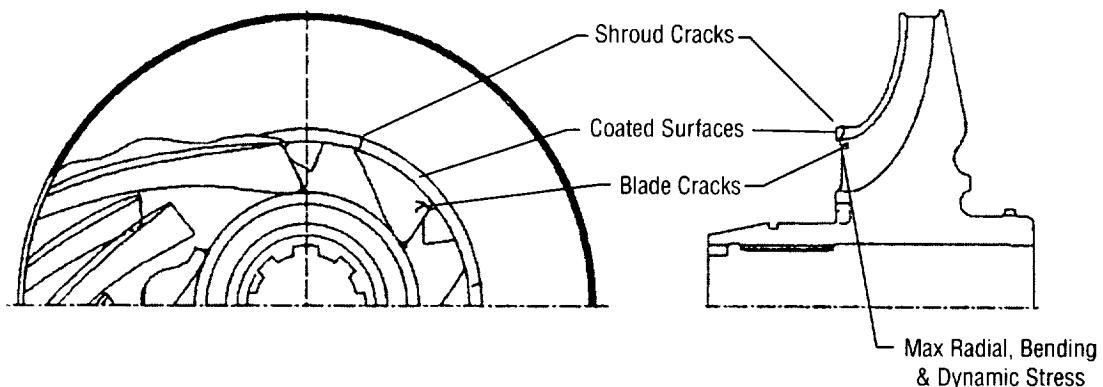
The failed impeller is the third stage of the pump side of the AT/HPFTP (see cross section in fig. 1 for location). It is machined from an A110 extra-low interstitial (ELI) titanium forging. Tungsten carbide coatings were applied to the rub stop surfaces to protect the titanium from direct contact with stelite surfaces on the mating face seals. An inlet and side view of the impeller are shown in figure 2. Identified in the figure are the posttest crack locations and the location of the rub stops. The cracks in the shroud initiated at the outer diameter corner of the rub stop and progressed up to 22 mm (0.85 in.).

Figure 2. Third impeller end and section views showing crack locations.

Microstructural evaluation of the hardware² showed that the titanium material at the rub stop had experienced temperatures >1,311 K (1,900 °F) evidenced by changes in the phases of the microstructure. The temperatures were below <1,844 K (2,860 °F) since melting of the titanium was not observed. The tungsten carbide coating was heat-checked and missing small pieces.

The experimental data from the residual stress measurement compared favorably with the analytical predictions. This confirmed that redesigning the thrust balance system to accommodate the transient engine start and shutdown conditions without rub was the proper corrective action. The transient axial loads are now reacted in the pump end ball bearing at start and a separate IN 100 rub ring at shutdown. Subsequent pump builds have demonstrated the redesign's effectiveness at eliminating the frictional heating-induced cracking.

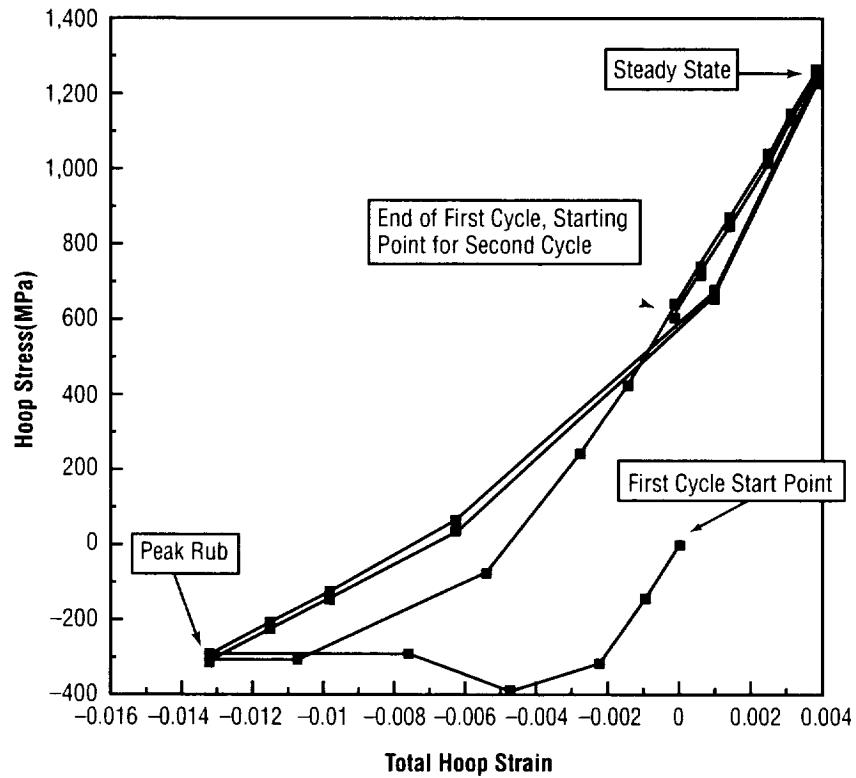
A finite element model (FEM) of the local region of the rub stop was run using nonlinear material properties and the thermal profiles generated by Goode³. The resulting rub stop surface plastic stress versus strain cycle is shown in figure 3. The model was run for two cycles, which showed the stress strain hysteresis loop to be established. Note that the first cycle start point is at zero stress and strain, and during the peak rub, a 1.4-percent compressive strain is developed. The hoop stress is rather low since the titanium's Young's modulus has dropped, due to the high local temperature. At steady state operation, a very high hoop stress is present since the compressive yielded titanium is now being cooled by the hydrogen. The end of the first cycle is when the engine is shut down and the impeller returns to room temperature; this is also the starting point for the second cycle. Note the high tensile residual hoop stress of 620 MPa (90 KSI). This residual stress is localized on the surface of the rub stop to a depth of 0.8 mm (0.03 in.), after which it decays rapidly with increasing depth. This corresponds to the depth of the heat-damaged region.

Figure 3. Results from nonlinear finite element analysis showing stress-strain hysteresis loop in AT/HPTFP third impeller pump side rub stop.
